Statistics Analysis Measures Painting of Cooling Tower

A. Zacharopoulou, E. Zacharopoulou, and G. Batis

This study refers to the cooling tower of Megalopolis (construction 1975) and protection from corrosive environment. The maintenance of the cooling tower took place in 2008. The cooling tower was badly damaged from corrosion of reinforcement. The parabolic cooling towers (factory of electrical power) are a typical example of construction, which has a special aggressive environment. The protection of cooling towers is usually achieved through organic coatings. Because of the different environmental impacts on the internal and external side of the cooling tower, a different system of paint application is required. The present study refers to the damages caused by corrosion process. The corrosive environments, the application of this painting, the quality control process, the measures and statistics analysis, and the results were discussed in this study. In the process of quality control the following measurements were taken into consideration: (1) examination of the adhesion with the cross-cut test, (2) examination of the film thickness, and (3) controlling of the pull-off resist

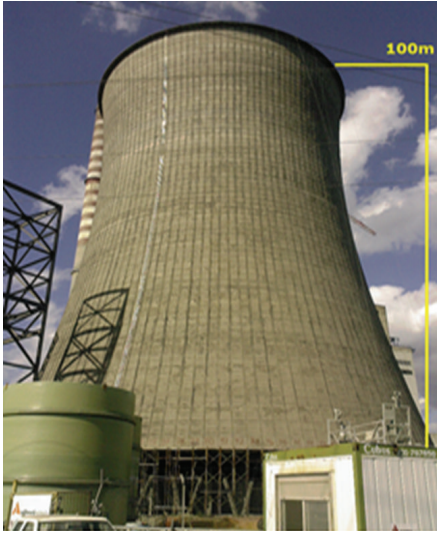
FIGURE 1: Cooling tower unit III of Megalopolis.

The transfer of water creates the conductive environment which favors the corrosion of reinforcement in concrete. On the outside surface the influence of carbon dioxide is strong, because around the cooling tower was the chimney of turbines factory, which reduces the pH and oxygen and promotes creates of the oxides. Additionally it is mentioned that there are four additional power plants in the region around the cooling tower. Through this analysis, we conclude that on the outside surface of the tower signs of corrosion of the reinforcement are more likely to occur [5]. The inspection of the cooling tower verifies this theoretical picture (Figure 1).

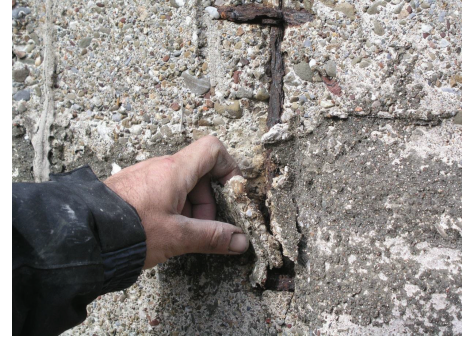
FIGURE 2: Ablation of concrete, before maintenance.

There were cases, as in Figure 2 (thickness carbonation was 36 mm), that the depth of carbonation has overcome the concrete coverage.

Due to both operational and environmental conditions, the towers are liable to malfunctions because of the corrosion of the reinforcement. The cooling towers show many problems of corrosion of the reinforcement (Figure 2). In this particular case, on the outside surface, in many places the reinforcement had been corroded and the cover of concrete was removed. At various points, the corrosion of reinforcement has reduced the diameter of rebar; therefore, the reinforcement must be cut and restored with new section of reinforcement. In this particular case, much attention was paid to the protection of reinforcements against corrosion and against carbonation in order to repair the tower [6, 7]. The applied method of protection against corrosion was the use of organic coatings. The requirements for the painting systems are explained in the instruction VGB "R 612 Ue" [8] (Protection Measures on Reinforced Concrete Cooling Towers and Chimneys against Operational and Environmental Impacts). Please note that the repair study was completed before application of EN1504.

- (i) Removal of the covered parts of concrete to such an extent as to gain relevance of 1.5 MPa. In particular for the concrete of the inside surface of the cooling tower has to be the layer of organic deposits, which had been formed removed.
- (ii) Cleaning of corroded reinforcement from corrosion products mechanically. Replacement reinforcement, which is necessary.
- (iii) Coating of reinforcement with cementitious coatings.
- (iv) Rehabilitation of concrete repair mortar.
- (v) Protection of the cooling tower with an organic system coating on the surface of concrete.

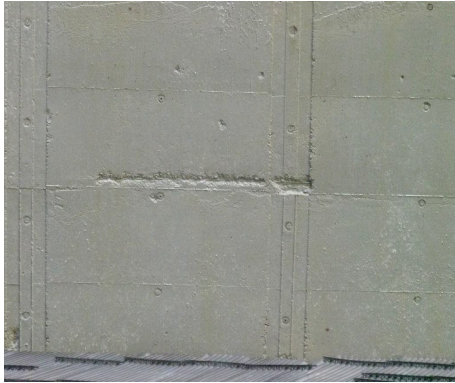
FIGURE 3: Concrete after maintenance.

The final figure of the surface of the concrete after repair is shown in Figure 3.

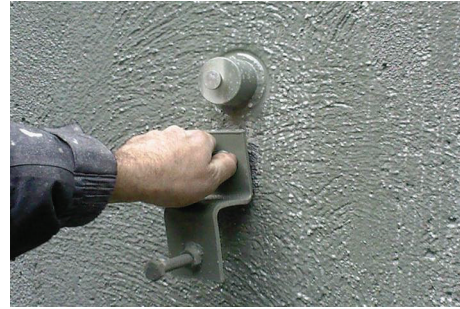
FIGURE 4: Pull-off test.

3.1. Controlling of the Pull-Off Test. Purpose of this method is to estimate the relevance of repair mortar concrete to the painting and to estimate the relevance of old concrete to the painting. According to BSEN 24624 (93) and ISO 4624 (1978) (Figure 4).

3.1.1. Acceptance Measures. The testing of the pull-off was acceptable when the measures were better than $\beta_{\text{HZ}} = 1.5 \text{ N/mm}^2$. This value was chosen according to VGB "R 612 Ue."

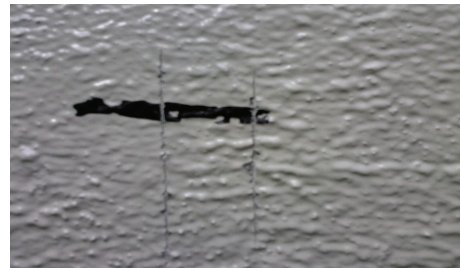
FIGURE 5: Cut test: measuring of the film thickness.

3.3. Measuring of the Film Thickness. The examination of the film thickness of the relevant surface protection coating shall be done with the wedge-cut test according to DIN 50986 [9]. Purpose of this method is to estimate the film thickness of concrete and also the film thickness of reinforcement (Figure 5).

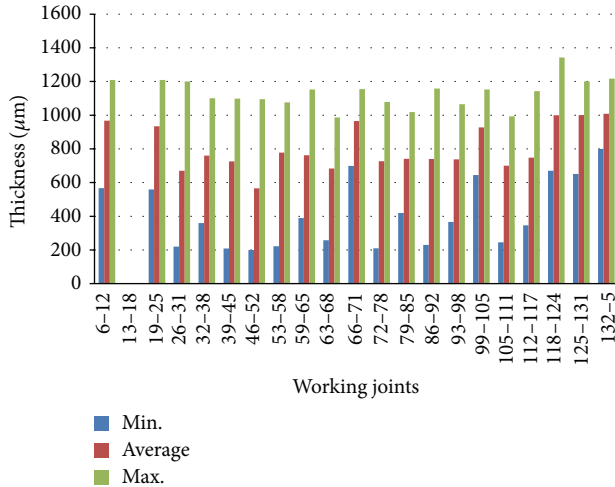
FIGURE 6: Thickness corrosion protection of rebar with cementitious coating for external shell.

Figure 6 shows the averages of measurements of the thickness of cementitious coating of reinforcement on the outside of the cooling tower. The axis X showed the separation areas of cooling tower. The average of measurements was not 1000 μm (according to the convention) but 850 μm .

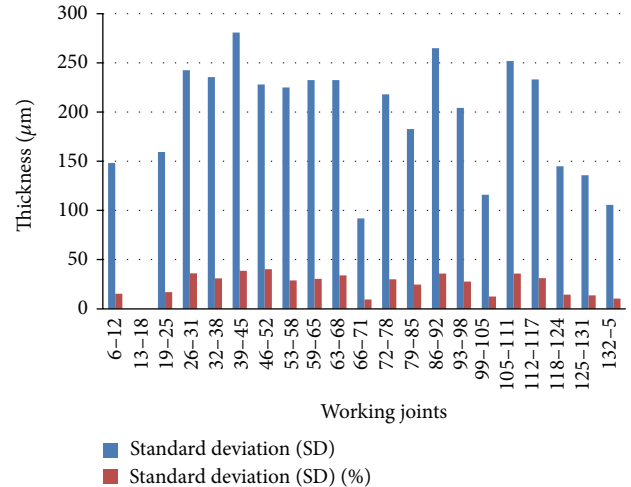
FIGURE 7: Standard deviation of reinforcement of external shell.

Figure 7 shows the standard deviation of cementitious coating of reinforcement which was almost 195.23 μm in all working joints. The axis X showed the separation areas of cooling tower.

From the above measurements we come to the conclusion that the difference between maximum and minimum value is 650 μm . The overall distribution of coating thickness follows the normal distribution.

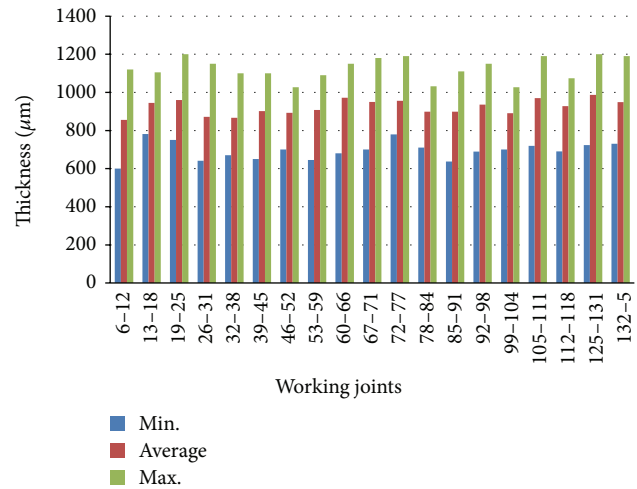
FIGURE 8: Thickness protection coating of reinforcements (μm) for internal shell.

Figure 8 shows the average measurements of the thickness of the anticorrosion coating of reinforcement on the inside of the cooling tower. It should be noted that the reinforcements, in general, were not covered with mortar repair. For the reinforcements above the ring of the cooling tower, the thickness of organic coatings had to be 950 μm (the thickness of cementitious coating 500 μm , the epoxy paint of concrete 300 μm , and polyurethane 150 μm). For the reinforcements under the ring of the cooling tower the

thickness of paint had to be $800 \mu\text{m}$. The average of values amounts to $875 \mu\text{m}$. After applying the cement coating of reinforcement, it was followed by the application of mortar repair. After the restoration of concrete organic coatings were applied.

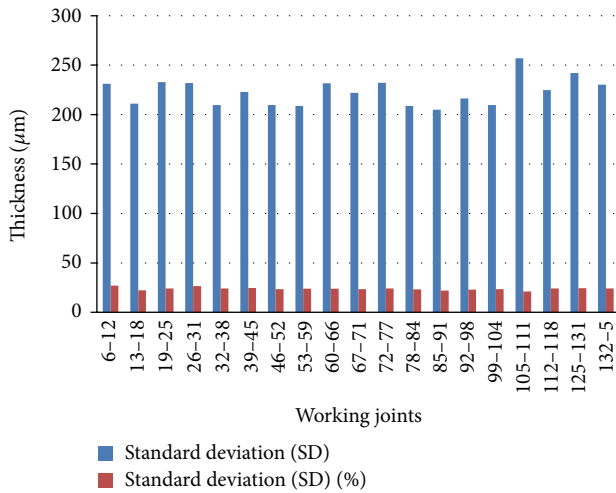
FIGURE 9: Standard deviation of the total thickness coatings to concrete surface of the internal shell.

Figure 9 shows the standard deviation of measurements of the thickness of the anticorrosion coating of reinforcement on the inside of the cooling tower which was almost $223 \mu\text{m}$ in all working joints. The axis X showed the separation areas of cooling tower. Analytical measurements of Figures 8 and 9 are presented in Table 3.

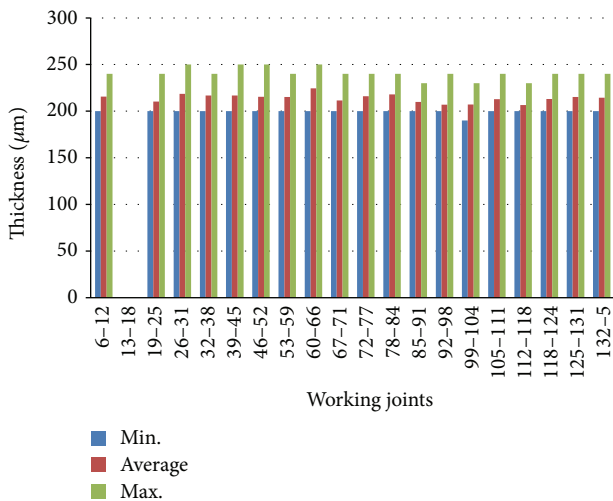
FIGURE 10: Overall thickness paintings external shell.

Figure 10 shows the total coating thickness of acrylic coating on the outside of cooling tower. The thickness of the acrylic coating should be $200 \mu\text{m}$. According to Figure 10, all measurements were greater than the limit ($200 \mu\text{m}$).

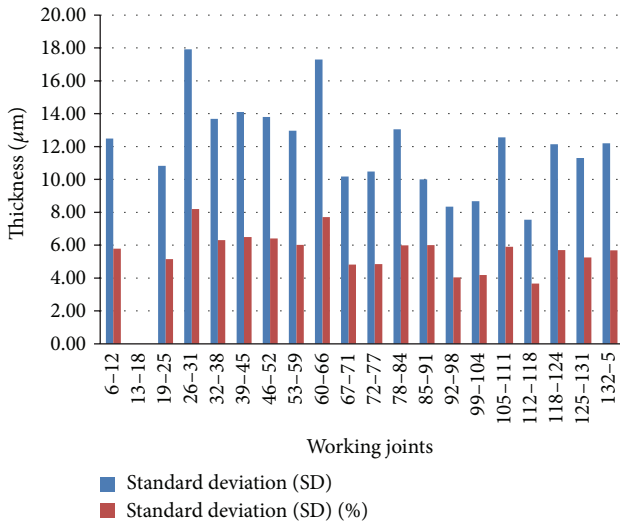
FIGURE 11: Standard deviation of acrylic emulsion coating on the surface of external shell.

Figure 11 shows the standard deviation and the standard deviation% of measurements of the coating outside of the cooling tower. The average standard deviation was almost $12.1 \mu\text{m}$ in all working joints. It is remarkable that the painting of concrete is simpler than the painting of reinforcement. Analytical measurements of Figures 10 and 11 are presented in Table 5.

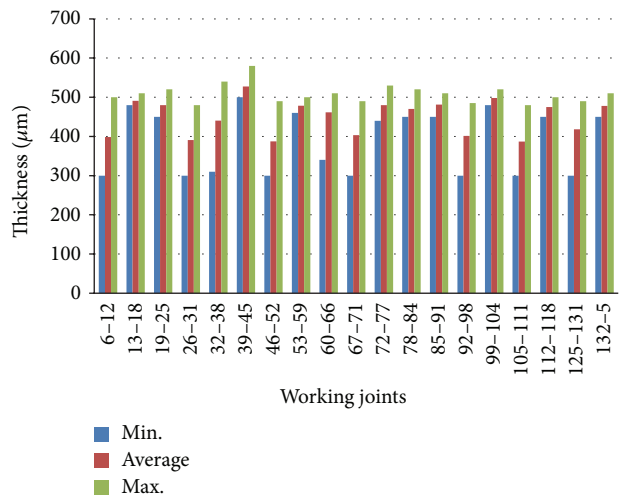
FIGURE 12: Total thickness of organic coatings (μm) on the surface of concrete internal shell (above the ring).

Figure 12 shows the total coating thickness of organic coatings on the inside surface of the cooling tower. On the inside surface of the cooling tower two cases were presented (Table 6):

- (i) under the ring of the cooling tower where the thickness of the coatings had to be $300 \mu\text{m}$ epoxy paint,
- (ii) above the ring of the cooling tower where the thickness of the coatings had to be $450 \mu\text{m}$ ($300 \mu\text{m}$ epoxy paint and $150 \mu\text{m}$ polyurethane).

Figure 12 indicates that the average is $400 \mu\text{m}$. Even the minimum values of measurements are over $350 \mu\text{m}$.

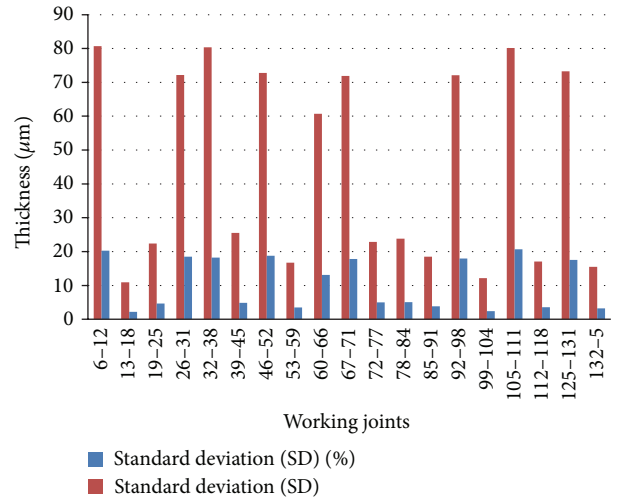
FIGURE 13: Overall standard deviation of paintings of internal shell (above the ring).

Figure 13 shows the total coating standard deviation% and the standard deviation of organic coatings on the inside surface of the cooling tower. The average of standard deviation% was 10.59. Analytical measurements of Figures 12 and 13 are presented in Table 4.

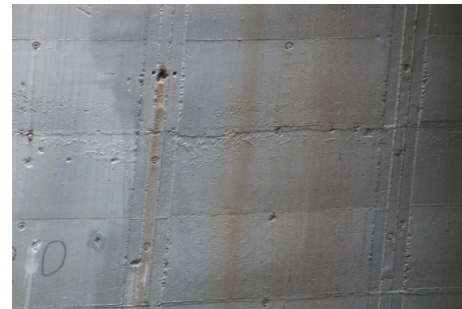
FIGURE 14: After a year of use of the cooling tower.

After one year of operation, the cooling tower was shut down for three days to allow for the necessary maintenance works. Because of short time, it was not possible for measurements to be taken. During this time, an optical inspection of the internal tower was made, which showed good behavior of coatings. The reinforcements, which did not have mortar concrete, showed no general corrosion. As is evident from Figure 11 (inner part), the state of epoxy coating is generally good and delamination and bubbles were not observed.

The repair of concrete showed no problems. Red spots are corrosion products from the oxidation of protruding steels. This protruding steel is not reinforcement and exists only for the initial works. The protruding bars are covered only with epoxy primer.

Figure 14 shows that reinforcing bars, which protrude outward, are not part of the structure but simply exist only for supporting reasons.
