Research Article

The Thickness Distribution of Oxidation Film on Tapered Pipe Surface in Dieless Drawing

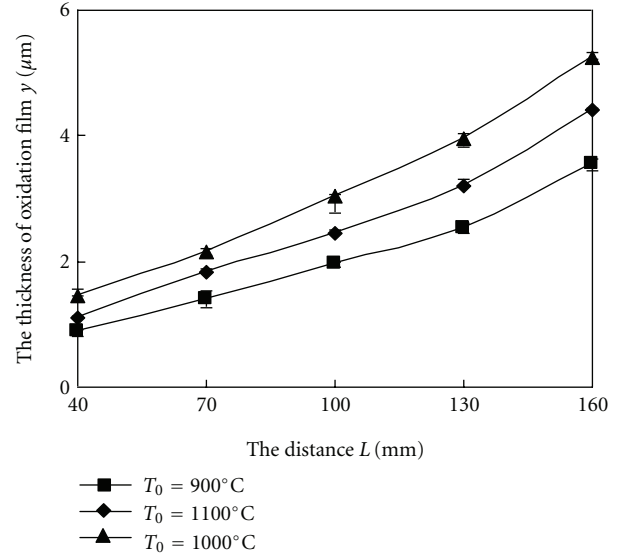
FIGURE 3: Thickness distribution of oxidation film on tapered pipes surface at the different induction heating temperatures.

We defined the end of tapered pipe with a largest diameter of 6 mm as origin. The thickness distributions of oxidation film on the tapered pipe surface are shown in Figure 3, when the feed speed was $20\text{ mm}\cdot\text{min}^{-1}$, the distance between heat and cold sources 40 mm, the induction heating temperature 900, 1000, and 1100°C , respectively. Figure 3 indicates that the thickness of oxidation film (y) at the distance (L) of 40 mm from origin was 0.88, 1.11, $1.46\text{ }\mu\text{m}$, respectively, for different heating temperatures. However, when $L = 160\text{ mm}$, $y = 3.55, 4.4, 5.25\text{ }\mu\text{m}$, respectively. The thickness of oxidation film on the surface of tapered pipes increased gradually with the increase in the induction heating temperature, and deformation degree.

In dieless drawing process of AISI304 stainless steel tapered pipes, the oxidation time is shortened with the increase in drawing velocity and tapered pipe length, however, oxidation film thickens, as shown in Figures 3–5. On one hand, the research indicates that oxidation film forms on the heated metal surfaces at high temperature, but the oxidation film blisters and cracks due to inner stress in it, which were found on the surface morphology of oxidation film when AISI 304 stainless steel is heated to 900°C without deformation as shown in Figure 6(a). Many tiny channels consist of microcracks in the oxidation film, and oxygen atoms can go through these channels and then react directly with metal matrix, which cause the increase in oxidation rate. On the other hand, the metal suffers a large plastic deformation in the deformation zone during the dieless drawing process, and surface oxidation film is also changed.

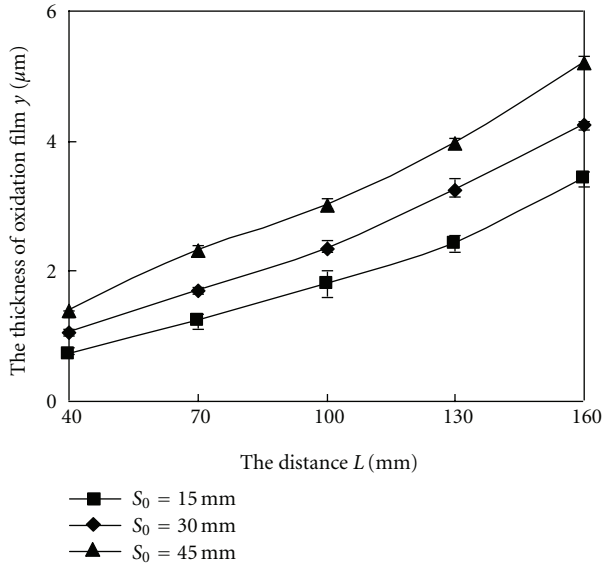
FIGURE 4: Thickness distribution of oxidation film on tapered pipe surface for different the distance between heat and cold sources.

Figure 4 shows the effect of the distance between heat and cold sources (S_0) on the thickness of oxidation film, when the feed speed was $30\text{ mm}\cdot\text{min}^{-1}$, the induction heating temperature 1100°C , respectively. When $L = 160\text{ mm}$, $y = 3.41, 4.24, 5.21\text{ }\mu\text{m}$ for $S_0 = 15, 30, 45\text{ mm}$, respectively. The oxidation film thickened with the increase in the distance between heat and cold sources.

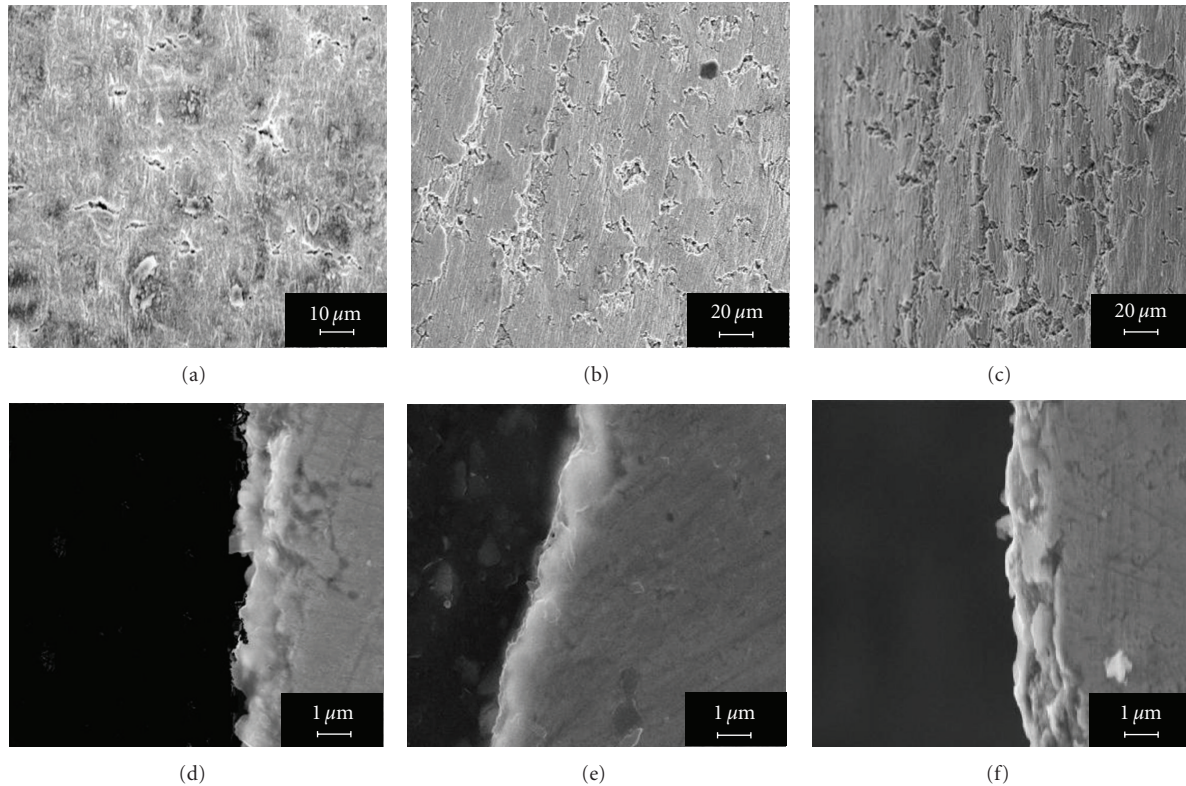
FIGURE 6: SEM images of oxidation film micromorphology. (a) the surface morphology of oxidation film without deformation and forming at 900°C in air; (b) the surface morphology of oxidation film forming at 900°C in air, and then deformation degree 5%, strain rate 10^{-3} s^{-1} at 900°C in vacuum environment; (c) the surface morphology of oxidation film forming at 900°C in air, and deformation degree is 10%, strain rate 10^{-3} s^{-1} at 900°C in vacuum environment; (d) the section plans of undeformed oxidation film; (e) the section plans of deformed oxidation film; (f) the section of surface oxidation film forming at 900°C in air after the deformation in vacuum environment: (i) epoxy resin, (ii) oxide film, and (iii) metal matrix.

Figures 6(b) and 6(c) show the surface morphology of oxidation film when the parameters are as follows: the induction heating temperature 900°C, the deformation degree 5 and 10%, respectively, in vacuum environment. Figure 6 suggests that there are massive cracks and ruptures in the surface oxidation film on the deformed metallic matrix. From the section plans of oxidation film, undeformed oxidation film reveals continuous floe structure (Figure 6(d)), while deformed oxidation film reveals discontinuous mass structure (Figure 6(e)). That indicates that the deformation of metal matrix introduces many ruptures of the oxidation film adhered to it. This is because that the oxidation film prefers brittle rupture due to its low plasticity, and a large amount of cracks are induced, and then the fresh metal surface is revealed, although a certain plastic flow occurs in surface oxidation film along the direction of deformation. However, metal oxidation resistance drops down and new oxidation speeds up rapidly when the fresh metal surface contacts with oxidizing atmosphere directly. Figure 6(f) shows the section of surface oxidation film which formed at 900°C in air after the deformation in vacuum environment. Due to the existence of many cracks in oxidation film, the thickness of oxidation film formed for a shorter oxidation time during the deformation process is even greater than that generated on the undeformed metal for a longer time, which brings some difficulties to the control and evaluation methods for oxidation degree in the dieless drawing process. By Figures 6(b) and 6(c), it is seen that, the density and width of cracks in oxidation film are enlarged with the deformation degree of metal matrix. As a result, the thickness of new oxidation film increases with the increase in deformation degree. In the dieless drawing process, tapered pipes extend with the raise of the drawing speed and deformation degree, and the thickness of oxidation film increases gradually from the larger diameter end to the smaller diameter end along tapered
